Project no.: *CfP08-AIR-03-02-831882*

Project acronym: SealedwithoUTaKiss - SWAK

Project title: Non-destructive testing (NDT) of bonded assemblies

Set of samples and structures to be tested

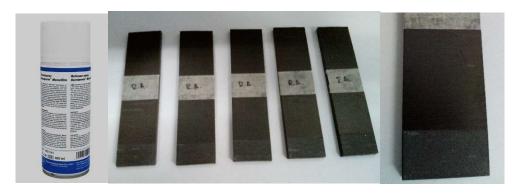
Figure 8. The Release Agent is applied on the surface of the joint around the bonding area

In the same manner Release Agent (SemipermMonofilm by R&G) is applied on the surface of the joint around the bonding area, as illustrated in figure 8. Before bonding, the release agent is left to dry for 24 hours. This product is silicone-free and suited for the purpose of processing of thermosets like polyester, epoxy and phenolic resins. It should be noted that this release agent is not suited for processing temperatures above 140 °C. During the curing of the adhesive film (177 °C) the release agent will dissolve and it will not prevent the bonding as intended by the manufacturer.

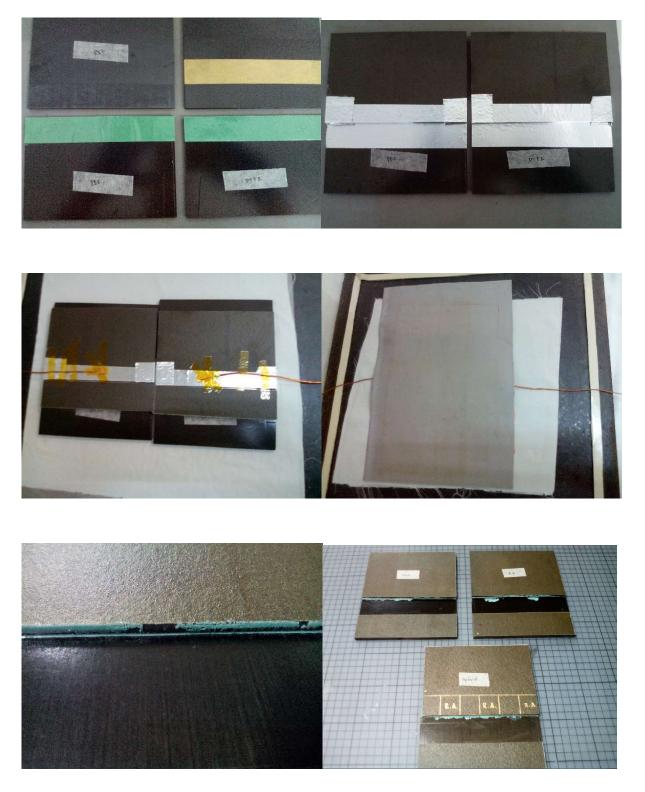
- 1. The samples are placed inside a vacuum bag and covered by consumable fabrics and a heat conductive silicon (Mosites).
- 2. The heating blanket is placed above the samples and negative pressure is applied using a vacuum pump (-0.8 bar).
- 3. The cure cycle is set to 180  $^{\circ}$ C for 70 min with a 3  $^{\circ}$ C/min rise.

Figure 21. The bonding procedure of lap shear test samples

The panels were bonded together using the hot bonder ANITA NG9201 and a heating blanket (50x50 cm). The recommended cure cycle as stated in the data sheet is 177 °C for 60 min. The bonding procedure is illustrated in figure 21. In all experiments the bonding is done using aeronautical grade adhesive film FM 300M. An aluminum tape is used to secure the plates during the bonding and to prevent the adhesive from leaking. This type of adhesive tape performs betters compared to Blue tape, Kapton tape and regular masking tape. In the final stage tabs were bonded using Acrylic adhesive (3M Scotch-Weld 8810).

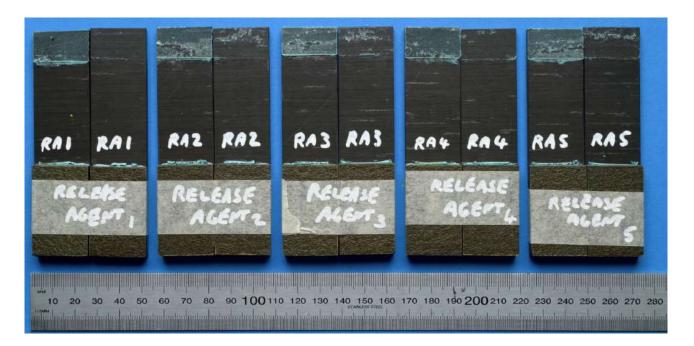
Image 6.5. Failure mode of Release agent contamination test samples

- Second weakest system but wide variation in results.
- Average failure strength exceeds 20% threshold.
- Mixed failure mode on some samples ie adhesion/cohesive for RA2, 3 and 5 but RA1 and RA4 almost complete adhesion failure.
