Brunel
University
London

Brunel Innovation Centre

Evaluation of NDT techniques for the detection of kissing bond defects in composite joints

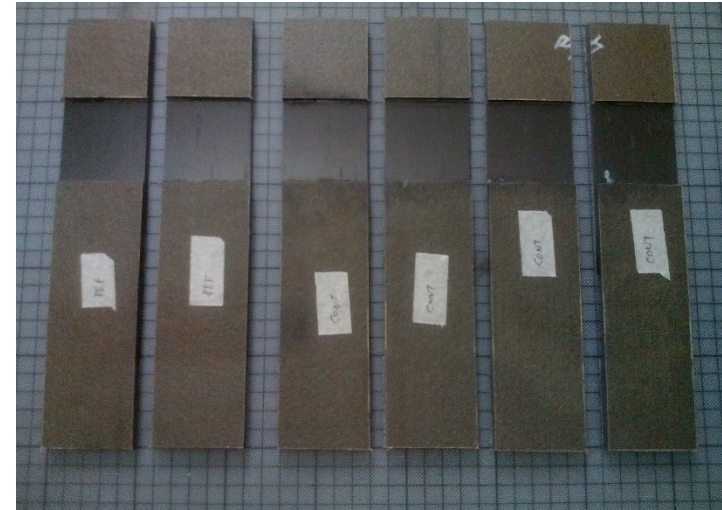
Bonded joint preparation:

- composite plates are bonded together using an adhesive film and by applying pressure and heat in autoclave oven
- bonding is done using aeronautical grade adhesive film FM 300M
- cure cycle is 177°C for 60 min
- Defective samples are created by contaminating the bonded area using Lithium Grease (WD40 or similar) as contamination.

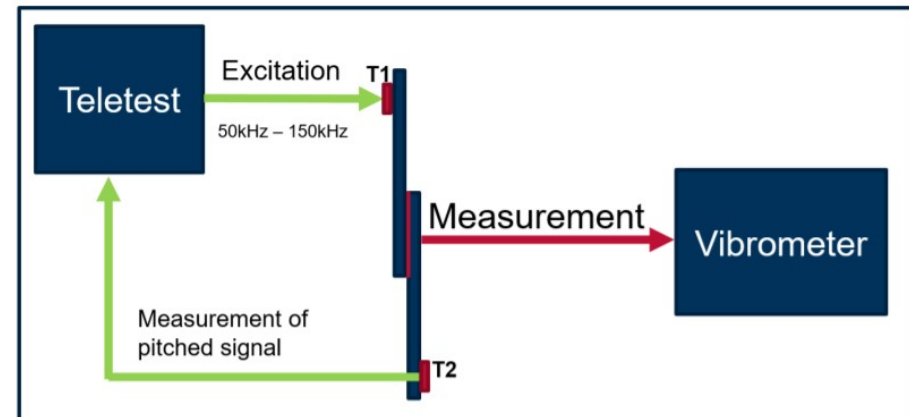
Guided waves NDT:

- Test samples in the picture
- Transducer: ASS-3000-0070-B Fuzz Button Piezo Element & Bonded Face Plate
- Equipment: TELETEST Mk4, Laser vibrometer of 2MHz
- I/P frequency: 50kHz to 150kHz

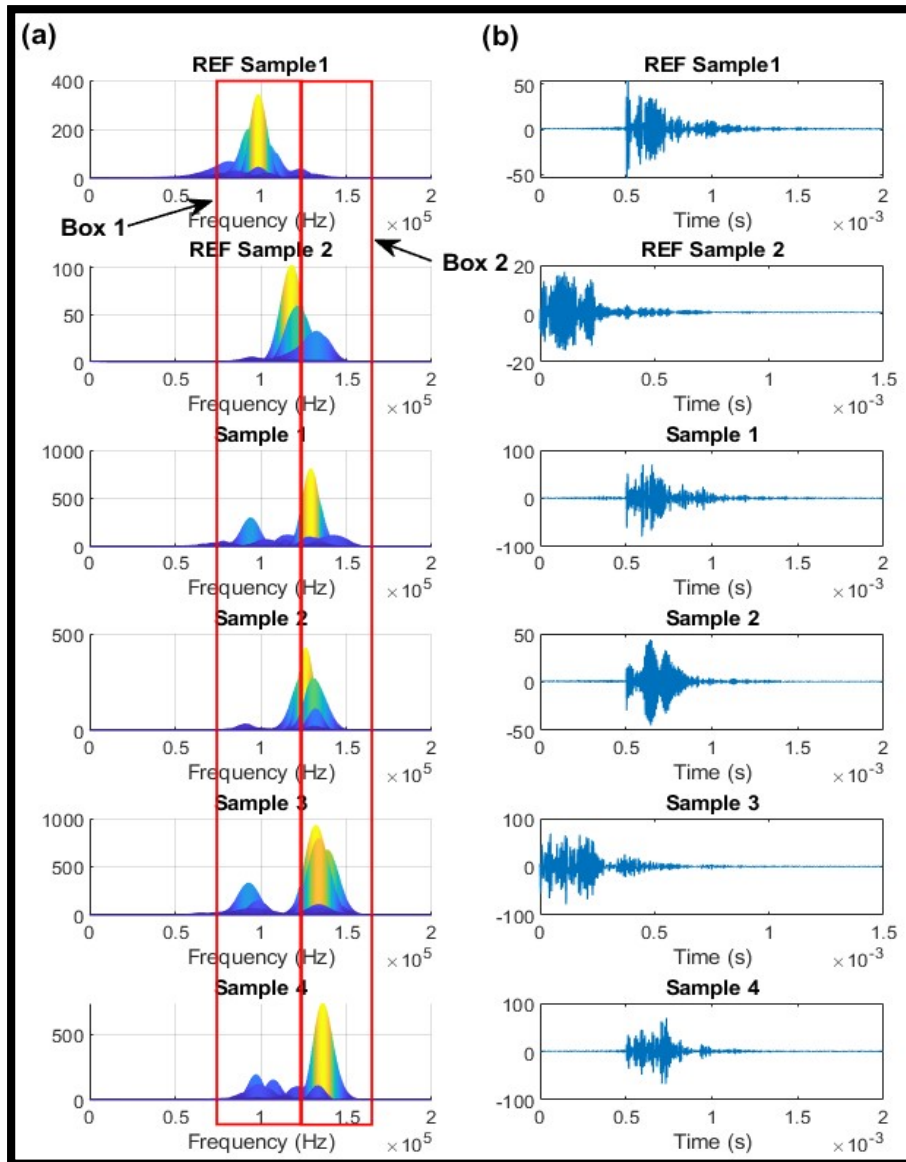
Teletest results

- There is a frequency shift
- Freq of max amplitudes lie below 125kHz for ref samples
- Freq of max amplitudes lie above 125kHz for samples with defects
- The defects can be identified using guided waves

- **Bonded joints with kissing bond defect have been successfully created and a protocol for the same is made**
- **Both guided wave NDT and laser shock test are conducted and the results are promising.**
- **A consistent frequency shift is observed which differentiates a bonded joint with kissing bonds and without kissing bonds**
- **High frequency C-scan and CT-scan are under trials**
- **CT-scan has shown some signs of defect detection which has to be validated**

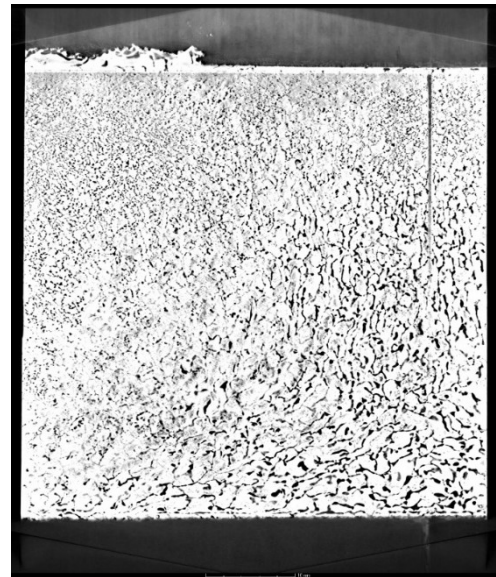
Computed Tomography:

- Results of CT-scan are shown in the pictures below.
- There is a sign of detection of defects.
- Results need validation.
